Relative Blade Pitch Angle Misalignment Verification

Case study: Dynamic Relative Blade Pitch Misalignment Measurements with Visual Inspection

Wind turbine:	SENVION MM92, 2.05MW, Rotor 92m

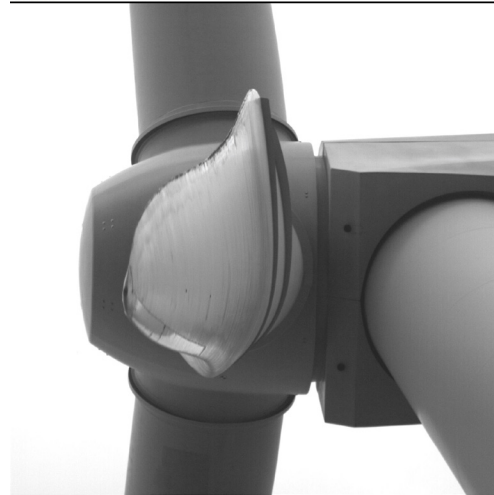
Blade: 2, Rotation: 1

Relative blade pitch angles misalignment detected

Blade 1 – Blade 3	-0.85°
Blade 1 - Blade 2	-0.12°
Blade 3 - Blade 2	0.73°

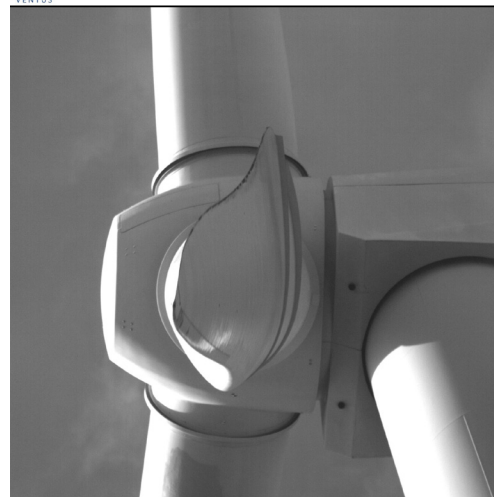
Blade: 1, Rotation: 1

Relative blade pitch angles misalignment verified after correction

Blade 1 – Blade 3	0.03°
Blade 1 - Blade 2	-0.11°
Blade 3 - Blade 2	-0.14°

From the above presented results, it can be noted that there has been a successful correction from a detected maximum relative blade pitch angle misalignment of -0.85° to an accepted by type certification maximum relative blade pitch angle misalignment of -0.14° . For the correction of the detected misalignment, Ventus visual inspection results were used from the OEM.

Another important observation derived from the detection and verification of the relative blade pitch angle misalignment is the flapwise blade bending differences are not present after the correction made by the service team.
